**PPG Aerospace**  
Transparencies

**Subject:** Manufacturing effects on Pilatus PC-12 Main Windshields

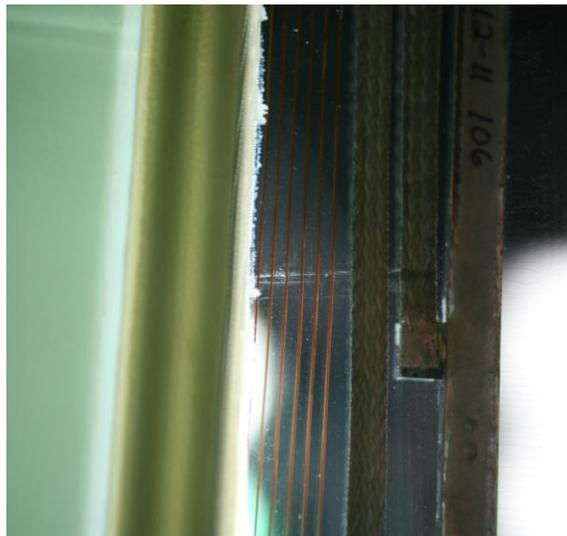
**Photo #1**

Customers have expressed concern that an observed "mark or line" in the window extending from the edge inside the routing of the wiring (see photo below) may be delamination, a scratch, or a crack. The area may have a translucent appearance but typically will appear along the wiring in the window. The "3" photos below are an example of different manifestations of this manufacturing effect.

The straight line marks observed along the side of the window or the translucent marks at the top corner around the braid and sensing element wires occurs when the window is being laminated. This window is a "2 ply" design meaning there are 2 pieces of glass laminated together with a vinyl heating mat in-between the glass. The fiberglass is bonded to the surfaces of the glass plies in a proprietary process that gives PPG windshields their unique durability. The Fiberglass is made up of glass fiber strands encased in an epoxy "resin" for strength. During the lamination process the window is heated under pressure, where the fiberglass resin reaches a "liquid" state and flows to bond to the surface of the glass before finally curing to a hardened state. As the fiberglass flows it will flow to the area of least resistance. Any area where wires have been routed into the glass is a path for the resin to flow. In the case where there is a straight line such as Photos #1 & #2, the vinyl between the windows has to be cut to route the braid wires through. A close inspection of the "mark" will show it lines up with a "dark" line on the braid wire. The dark line across the braid wire is where the braid wire was bent at a 90 degree angle to route up through the vinyl. This is where the vinyl is cut. When the window is in the oven the fiberglass resin will melt before the vinyl does and flow into the cut in the vinyl. Once the vinyl melts the resin is encapsulated in the vinyl. This can actually be viewed using a 10X loupe to examine the mark. The resin flow that occurs at the top where the braid wires & sensing wires are routed into the glass occurs much the same way except that in this case the wires act as "wicks" during the oven operation. The wires absorb heat and the resin will flow along the wire and spread from the wire. The actual entry point of the wire from the fiberglass edge into the vinyl is a difficult area to totally eliminate any resin flow. The process is further complicated by the amount of resin present in the fiberglass, the temperature & humidity during production, and the operator who builds the unit by hand. PPG controls the manufacturing process very closely and some windows are produced that with perfect conditions no resin flow is visible. However, this is a rare event and if required to produce all windows with no resin flow visible at all would increase the cost of each windshield enormously.
