SERVICE LETTER

SUBJECT: HARTZELL SERVICE BULLETINS HC-61-224, REV.2 - PROPELLER PART - STOCK INSPECTION AND HC-61-224, REV. 2 - PRE-LOAD PLATE SET-SCREW INSPECTION

SERVICE BULLETIN HC-SB-61-224

SERVICE BULLETIN HC-SB-61-225

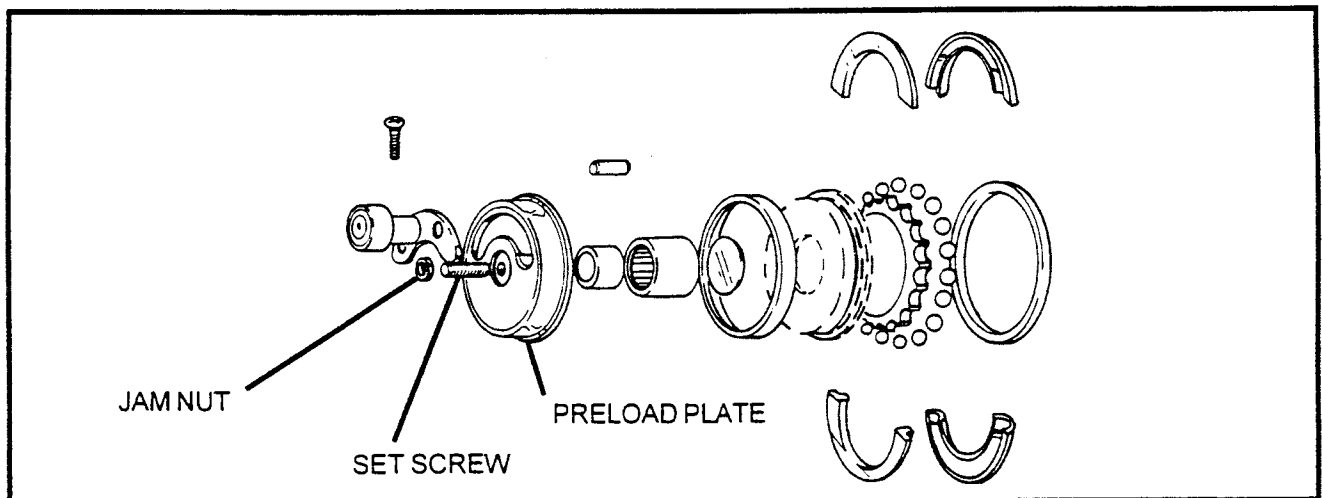
FIGURE 1.
TYPICAL BLADE COMPONENTS SHOWING SET SCREW APPLICATION

- (2) Two contributing factors are the hardness and, in some screws, the depth of the hex recess on the end of the screw (used for the internal wrench) was aligned with end of the external jam nut which combined to form a highly stressed area in the screw thread. Usage of a longer screw or a screw with a hex recess of less depth will reduce the stress concentration and provide improved strength.

- (1) Manually rotate prop and listen for possible noise caused by a broken set screw/jam nut that may be loose in the propeller hub, see Figure 1.
- (2) With propeller blades in feather position, visually check feather stop nut to be seated, see Figure 2.
- (3) If noise indicates a loose part (broken set screw) or if the propeller blades do not go all the way into feather, remove propeller and send to a propeller repair station for disassembly and inspection for a possible broken preload plate set screw.
 - (a) If a broken screw is found after disassembly, the propeller must be disassembled and inspected for damage that may have been caused by the broken screw.
 - (b) Report any such incidents to the Hartzell Product Support Department.

- (1) Replacement of preload plate set screws with new screws is required.
- (2) Use of A-3204-2 Set Screws in lieu of the previously specified A-3204 Set Screws is recommended, except for HC-A6A-3 model which continues to use only the A-3204. Use of A-3204-2 is preferred, however, A-3204 remains usable if it meets the inspection requirements of Hartzell Service Bulletin HC-SB-61-224.

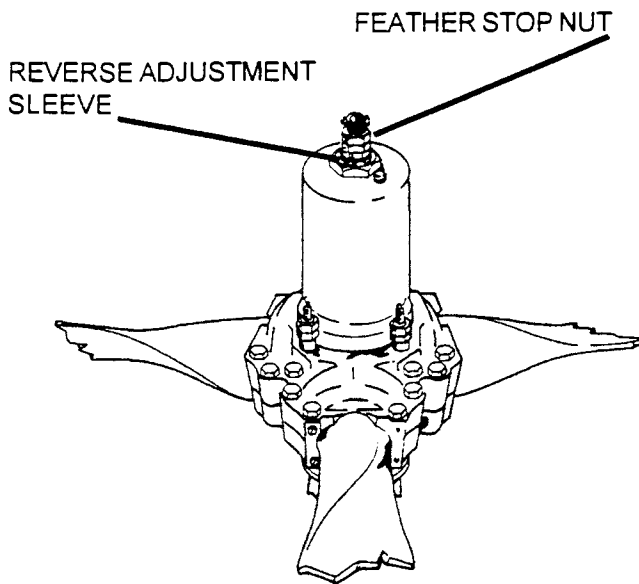
FIGURE 2.
FEATHER POSITION FOR 4, 5, 6 BLADE PROPELLERS

Four blade propeller, HC-(E,D)4(-):
Blades are in feather position when
feather stop nut contacts the reverse
adjustment sleeve.

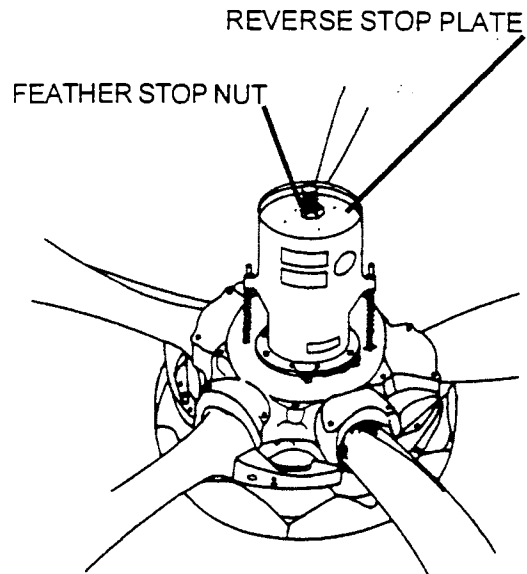
Five blade propeller, HC-E5(-):
Blades are in feather position when
feather stop nut contacts the reverse adjust
plate.

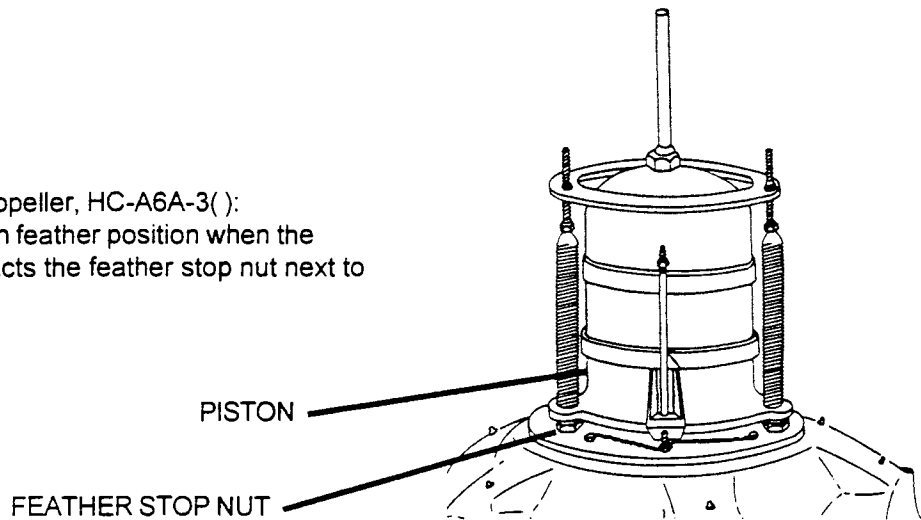
Six blade propeller, HC-A6A-3():
Blades are in feather position when the
piston contacts the feather stop nut next to
hub.
