SERVICE LETTER

SUBJECT: VICKERS SERVICE LETTERS 29-920422-01 & 29-933322-01 AND SERVICE BULLETINS 920422-29-02, 920422-29-03, 933322-29-01, 920422-01-29 AND 933322-29-02 - ELECTRIC MOTOR-DRIVEN HYDRAULIC PUMP ASSEMBLY.

Date: December 16/97

Appendix A to Pilatus Service Letter No. 028

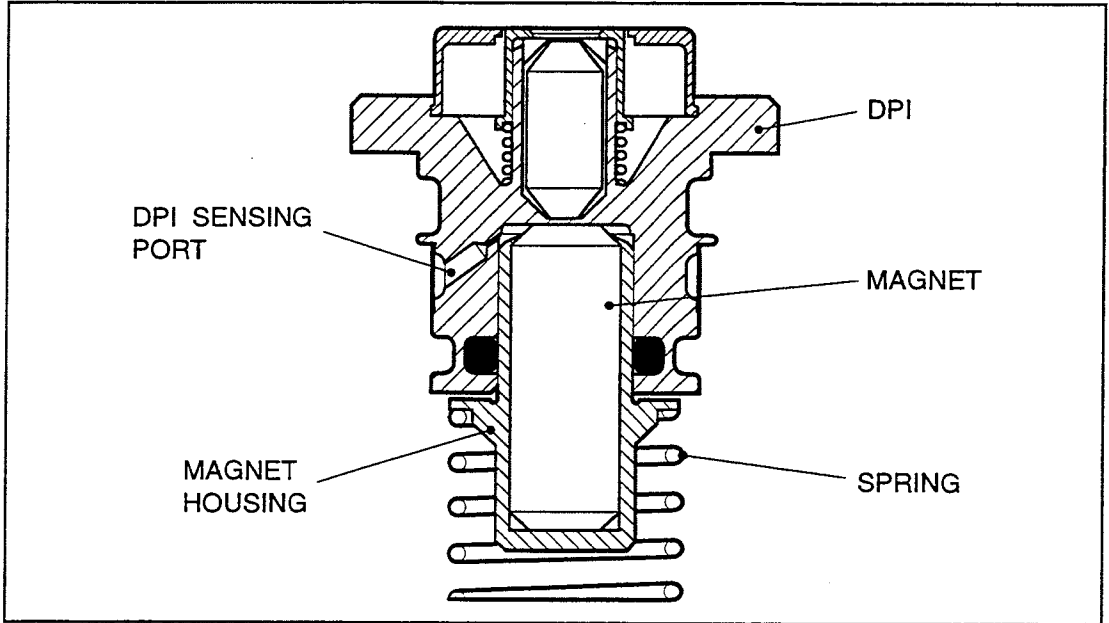
Find The Position Of The DPI Sensing Port
Figure 1

Investigation has shown that it is possible for the DPI to be put in one of four positions when it is installed in the adaptor subassembly. Thus the DPI sensing port in one hydraulic pump package assembly can be in a different position in relation to the adaptor inlet port in another. If the DPI sensing port is adjacent to the adaptor inlet port, the DPI will be more sensitive to high pressure spikes than if it is not.

Because it is thought that unwanted operation of the DPI can be caused by high pressure spikes, this Service Letter specifies the steps necessary to make the DPI less sensitive. To do this, the DPI sensing port must be positioned diametrically opposite (180°) the adaptor inlet port. This will help prevent unwanted operations of the DPI.

1. Disassembly.
 - A. Make a temporary mark with a soft-tip pen to show the position of DPI (110) in relation to adaptor subassembly (140).
 - B. Remove four screws (115) and washers (120) from the flange of DPI (110).
 - C. Remove DPI (110) together with its spring from adaptor subassembly (140).
 - D. Remove the spring, the magnet housing and the magnet from the body of the DPI.
2. Examination
 - A. Remove all unwanted hydraulic fluid from the magnet housing recess in the body of the DPI.
 - B. Refer to Figure 1 of this Service Letter. With the help of an additional light source, find the position of the DPI sensing port in the magnet housing recess. Record this position.

NOTE: You cannot see the DPI sensing port on the external surface of the DPI because of the filter screen. You must look for it from inside the magnet housing recess.
 - C. Refer to Figure 2 of this Service Letter. With the help of an additional light source, find the position of the adaptor inlet port. Record this position.
 - D. With the help of the temporary mark you made in step 1.A, compare the position of the DPI sensing port with the position of the adaptor inlet port when the DPI was installed in the adaptor subassembly. If the position of the DPI sensing port is found not to be diametrically opposite (180°) the adaptor inlet port, assemble the DPI as specified in the steps that follow. If the position of the DPI sensing port is found to be diametrically opposite (180°) the adaptor inlet port, embody Modification No 1 as specified in Service Bulletin 920422-29-02.

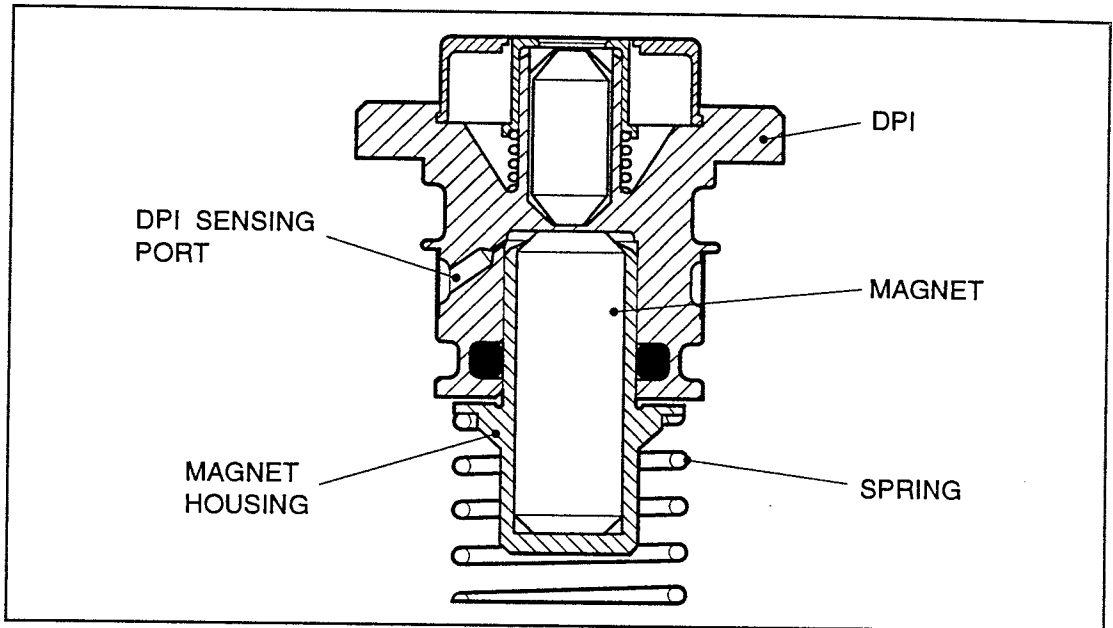
Find The Position Of The DPI Sensing Port
Figure 1

Investigation has shown that it is possible for the DPI to be put in one of four positions when it is installed in the adaptor subassembly. Thus the DPI sensing port in one hydraulic pump package assembly can be in a different position in relation to the adaptor inlet port in another. If the DPI sensing port is adjacent to the adaptor inlet port, the DPI will be more sensitive to high pressure spikes than if it is not.

Because it is thought that unwanted operation of the DPI can be caused by high pressure spikes, this Service Letter specifies the steps necessary to make the DPI less sensitive. To do this, the DPI sensing port must be positioned diametrically opposite (180°) the adaptor inlet port. This will help prevent unwanted operations of the DPI.

1. Disassembly.
 - A. Make a temporary mark with a soft-tip pen to show the position of DPI (155) in relation to adaptor subassembly (185).
 - B. Remove four screws (160) and washers (165) from the flange of DPI (155).
 - C. Remove DPI (155) together with its spring from adaptor subassembly (185).
 - D. Remove the spring, the magnet housing and the magnet from the body of the DPI.
2. Examination
 - A. Remove all unwanted hydraulic fluid from the magnet housing recess in the body of the DPI.
 - B. Refer to Figure 1 of this Service Letter. With the help of an additional light source, find the position of the DPI sensing port in the magnet housing recess. Record this position.

NOTE: You cannot see the DPI sensing port on the external surface of the DPI because of the filter screen. You must look for it from inside the magnet housing recess.
 - C. Refer to Figure 2 of this Service Letter. With the help of an additional light source, find the position of the adaptor inlet port. Record this position.
 - D. With the help of the temporary mark you made in step 1.A, compare the position of the DPI sensing port with the position of the adaptor inlet port when the DPI was installed in the adaptor subassembly. If the position of the DPI sensing port is found not to be diametrically opposite (180°) the adaptor inlet port, assemble the DPI as specified in the steps that follow. If the position of the DPI sensing port is found to be diametrically opposite (180°) the adaptor inlet port, embody Modification No 1 as specified in Service Bulletin 933322-29-01.

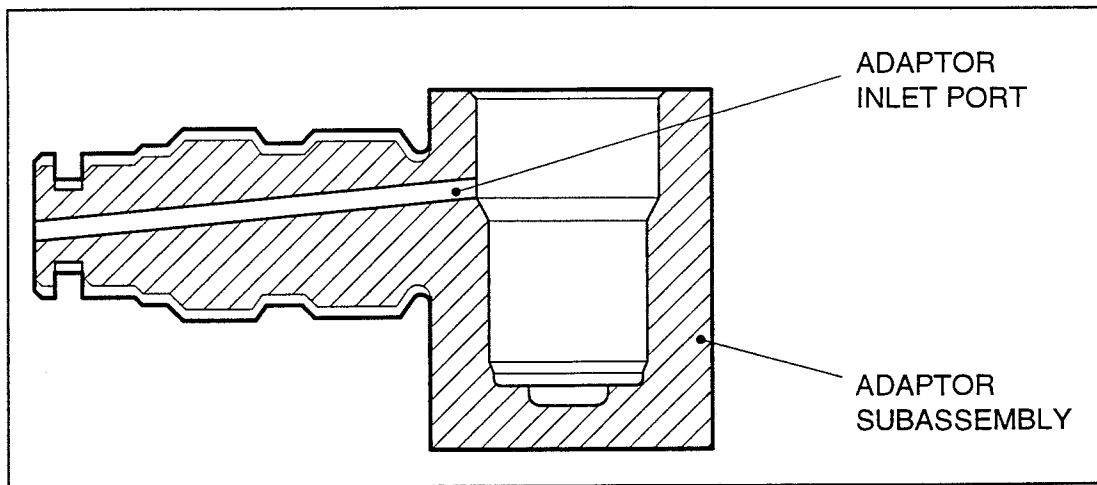
Find The Position Of The Adaptor Inlet Port
Figure 1

Unwanted operations of the DPI have occurred in service which give incorrect indications of a blocked filter. It is thought that this can be caused by high pressure spikes and mechanical shocks.

- (1) Install a new filter by-pass valve, Part Number M098007, in valve plate subassembly (265).
- (2) Torque the new filter by-pass valve to between 27,12 and 32,54 Nm (240,0 and 288,0 lbf in).
- (3) Lock the new filter by-pass valve to compensator bushing (255) with locking wire MS20995C32 as specified in Specification MS33540.

- (4) Refer to the reference Component Maintenance Manual 29-10-45. Install new packings (Part Number M83248-1-014 and M83248-1-015) and back-up ring (Part Number MS28774-015) in the related packing grooves of the new DPI, Part Number QA07881, in the positions shown.
- (5) Install the new DPI, Part Number QA07881, together with its spring in adaptor subassembly (140). Make sure that the location hole in the flange of the new DPI is diametrically opposite (180°) the mark that you made on the adaptor subassembly in step 3.A(5) .
- (6) Install four screws (115) and washers (120) in the flange of the new DPI and attach the DPI to adaptor subassembly (140).
- (7) Torque four screws (115) equally and symmetrically in a diagonally opposite sequence to between 1,81 and 2,26 Nm (16,0 and 20 lbf in).
- (8) Remove the temporary mark that you made on the adaptor subassembly in step 3.A(5).

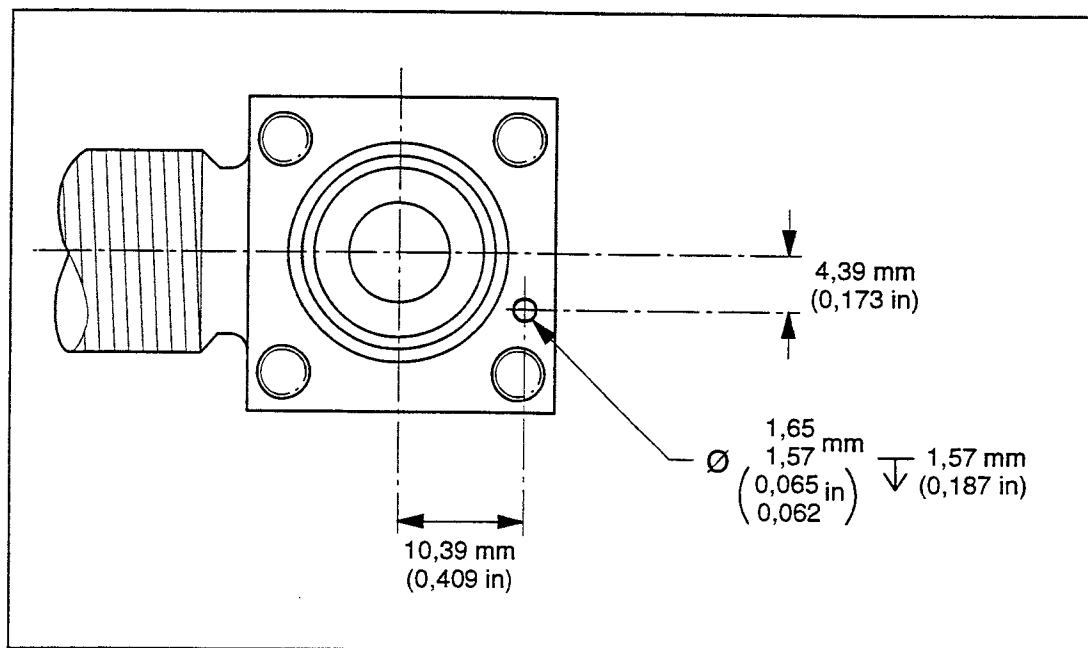
Position of the Locating Pin Hole
Figure 1

It is possible for the differential pressure indicator (DPI) to be put in one of four positions when it is installed in the adaptor subassembly. Thus the DPI sensing port in one hydraulic pump package assembly can be in a different position in relation to the adaptor inlet port in another.

To help prevent unwanted operation of the DPI, it is necessary for the DPI sensing port to be diametrically opposite (180°) the inlet port of the adaptor subassembly. Because of this, Vickers Systems Service Bulletin 920422-29-02 replaced the DPI with one that included a location hole in the flange (Mod 1). This hole is related to the position of the DPI sensing port, and thus helps you install the DPI in the correct position in relation to the adaptor subassembly.

- (1) Refer to Figure 1 of this Service Bulletin. Make a hole in the top face of the adaptor subassembly with a 1,65/1,57 mm (0,065/0,062) drill to a depth of 1,57 mm (0,187 in) in the position shown.

- (2) Deburr the hole. Remove all unwanted material from the hole and the adaptor subassembly.
- (3) Apply Alocrom 1200, or equivalent, to the hole as specified in the reference Component Maintenance Manual 29-10-45.
- (4) Install pin, Part Number 215723, in the related hole in the top face of the adaptor subassembly. Push the pin fully in the hole.

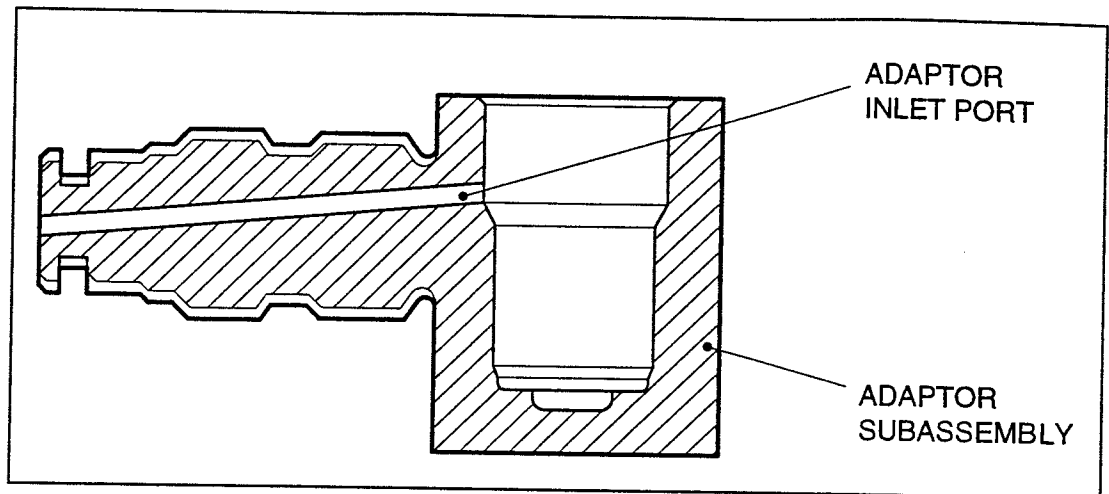
Find The Position Of The Adaptor Inlet Port
Figure 1

Unwanted operations of the DPI have occurred in service which give incorrect indications of a blocked filter. It is thought that this can be caused by high pressure spikes and mechanical shocks.

- (1) Install a new filter by-pass valve, Part Number M098007, in valve plate subassembly (310).
- (2) Torque the new filter by-pass valve to between 27,12 and 32,54 Nm (240,0 and 288,0 lbf in).
- (3) Lock the new filter by-pass valve to compensator bushing (300) with locking wire MS20995C32 as specified in Specification MS33540.

- (4) Refer to the reference Component Maintenance Manual 29-10-47. Install new packings (Part Number M83248-1-014 and M83248-1-015) and back-up ring (Part Number MS28774-015) in the related packing grooves of the new DPI, Part Number QA07881, in the positions shown.
- (5) Install the new DPI, Part Number QA07881, together with its spring in adaptor subassembly (185). Make sure that the location hole in the flange of the new DPI is diametrically opposite (180°) the mark that you made on the adaptor subassembly in step 3.A(5) .
- (6) Install four screws (160) and washers (165) in the flange of the new DPI and attach the DPI to adaptor subassembly (185).
- (7) Torque four screws (160) equally and symmetrically in a diagonally opposite sequence to between 1,81 and 2,26 Nm (16 and 20 lbf in).
- (8) Remove the temporary mark that you made on the adaptor subassembly in step 3.A(5).

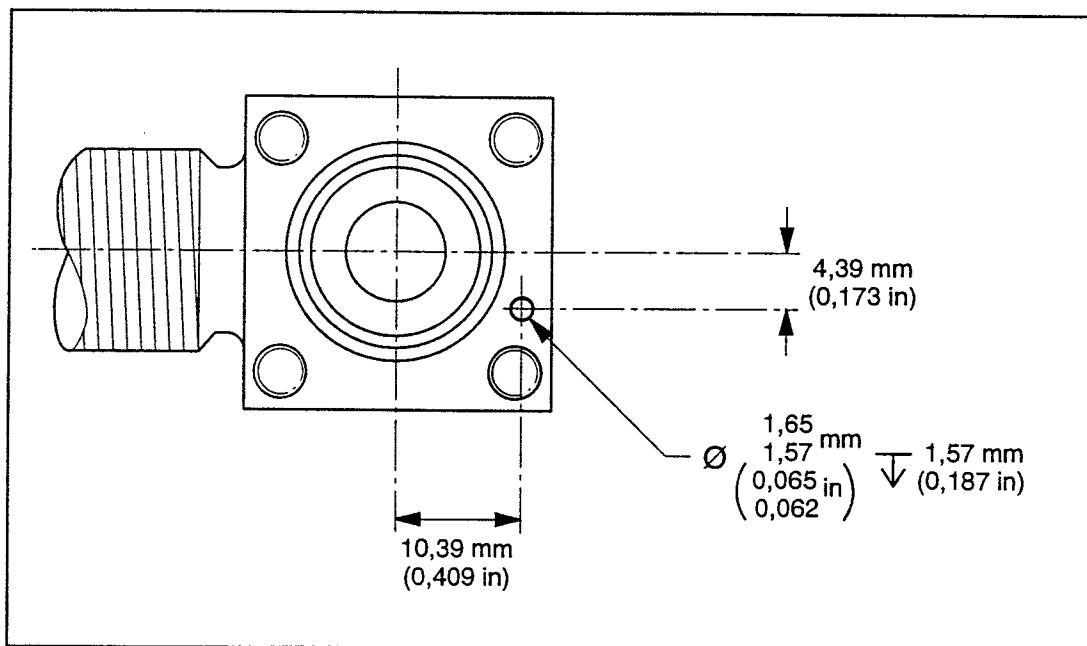
Position of the Locating Pin Hole
Figure 1

To help prevent unwanted operation of the DPI, it is necessary for the DPI sensing port to be diametrically opposite (180°) the inlet port of the adaptor subassembly. Because of this, Vickers Systems Service Bulletin 933322-29-01 replaced the DPI with one that included a location hole in the flange (Mod 1). This hole is related to the position of the DPI sensing port, and thus helps you install the DPI in the correct position in relation to the adaptor subassembly.

- (1) Refer to Figure 1 of this Service Bulletin. Make a hole in the top face of the adaptor subassembly with a 1,65/1,57 mm (0,065/0,062 in) drill to a depth of 1,57 mm (0,187 in) in the position shown.

- (2) Deburr the hole. Remove all unwanted material from the hole and the adaptor subassembly.
- (3) Apply Alocrom 1200, or equivalent, to the hole as specified in the reference Component Maintenance Manual 29-10-47.
- (4) Install pin, Part Number 215723, in the related hole in the top face of the adaptor subassembly. Push the pin fully in the hole.
