PILATUS AIRCRAFT LTD. CH-6371 STANS, SWITZERLAND

# SERVICE LETTER

**SUBJECT: P&WC SERVICE BULLETIN NUMBER PT6A-72-14254R1**

TURBOPROP ENGINE  
FUEL CONTROL UNIT - REPLACEMENT/MODIFICATION OF

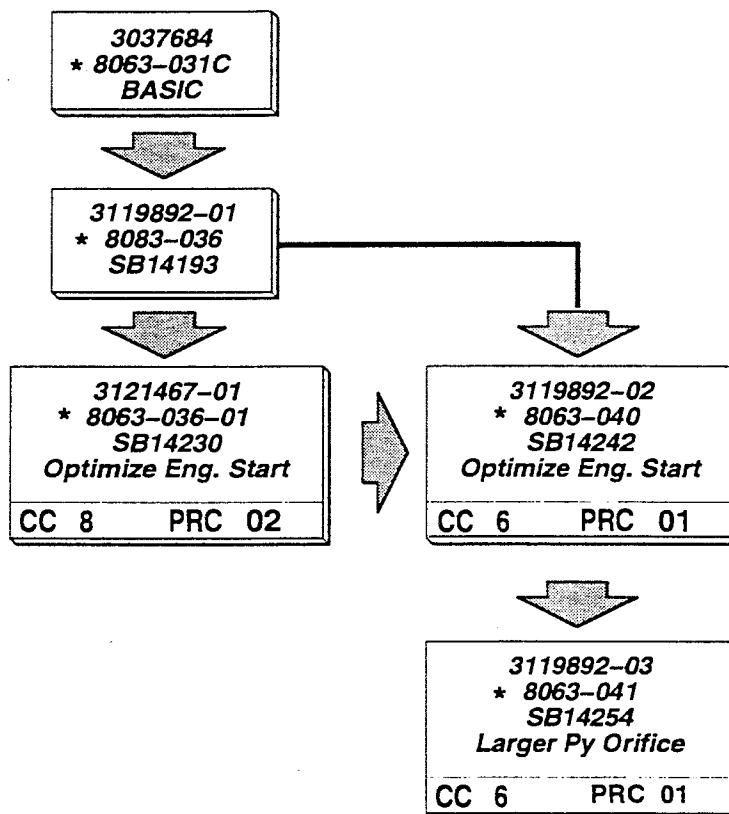
Progression of the Part  
Figure 1

A. Refer to Figure 1 for Parts Progression.

- (1) For engines incorporating P&WC S.B. No. 14242R1:
  - (a) Remove fuel control unit P/N 8063-040 (P&WC P/N 3119892-02)
  - (b) Install new or modified fuel control unit P/N 8063-041 (P&WC P/N 3119892-03).
  - (c) Write "P&WC S.B. No. 14254 Incorporated" in the engine log book.
- (2) For engines not incorporating P&WC S.B. No. 14242R1:

- (a) Remove fuel control unit P/N 8063-036 (P&WC P/N 3119892-01) or P/N 8063-036-01 (P&WC P/N 3121467-01).
- (b) Install new or modified fuel control unit P/N 8063-041 (P&WC P/N 3119892-03).
- (c) Write "P&WC S.B. No. 14254 Incorporated" in the engine log book.

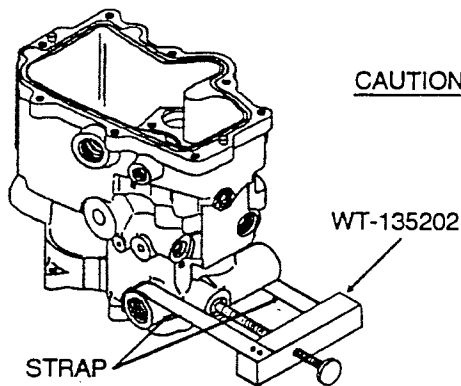
Figure 2

**CAUTION:** THE HOOKED STRAPS MUST BE FULLY SEATED ON THE BOSSES OF THE FCU HOUSING BEFORE APPLYING PRESSURE TO COMPRESS THE SPRING. FAILURE TO DO SO MAY RESULT IN DAMAGE TO THE TOOL.

- (1) Using WT-135202, as shown in Figure 2, press on plate (10, Figure 1) until tension on ring (5) is relieved. Depress ring (20) and remove ring (5) from housing assembly (25). Slowly turn screw of WT-135202 until there is no tension on spring (15).
- (2) Remove ring (20), packing (30), plate (10), spring (15), orifice (35), and packing (40) from housing assembly (25).
- (3) Replace Py orifice P/N 3540-064 with P/N 3540-082.

- (1) Install WT-135202 on housing assembly (25) as shown in Figure 2.
- (2) Install packing (40, Figure 1) in bore of housing assembly (25).
- (3) Install orifice (35), with seat facing packing (40). Install spring (15) and plate (10) in housing assembly (25).
- (4) Install ring (5), ring (20), and packing (30) on WT-135202. Using WT-135202, compress spring (15) past the ring groove in housing assembly (25) and install packing (30), ring (20), and ring (5) in housing assembly (25).
