SERVICE LETTER

SUBJECT: CREW SEAT PAN WEB - REPAIR

SERVICE BULLETIN: 5PC41000_MOD1 - (Minor Change)

SUBJECT: Repair Of Seat Pan Web Of PC12 Crew Seat

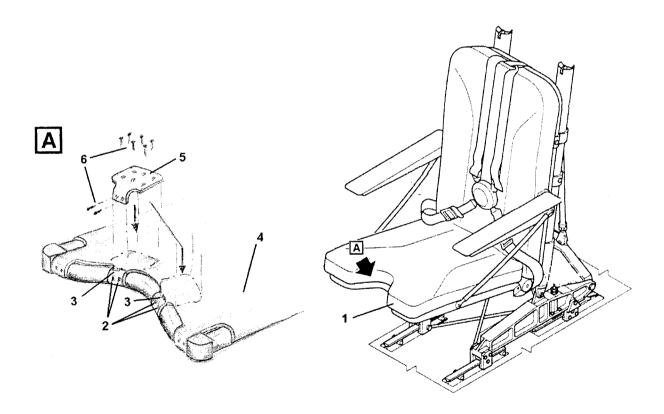
Figure 1 Repair Overview

Seat pan web cracked during service.

This Service Bulletin gives instructions for repair of seat pan webs that are found cracked during service, by adding doublers in the cracked area.

- 1) Obey the instructions provided in the PC12 aircraft maintenance manual (AMM) to remove the seat from the cockpit.
- 2) Remove the seat cushion (1).
- 3) Use a drill Ø3.8mm to remove the rivet (2) and the broken attachment strap (3) of the seat pan (4). Discard the rivets (2).
- 4) Use clamp fasteners to clamp the broken attachment strap (3) together with the doubler (5) to the front tube of the seat pan (4) and use the doubler (5) as a template to drill the holes in the seat pan (4).
- 5) Use clamp fasteners to clamp the doubler (5) to the seat pan (4) and drill the holes in the attachment strap of the doubler (5).
- Remove the clamp fasteners, the broken attachment strap (3) and the doubler (5) and deburr the seat pan (4) and the doubler (5).

- 7) Apply a layer of corrosion preventative (Alodine) to the blank area of the front tube of the seat pan (4), the seat pan (4), the doubler (5) and the broken attachment strap (3).
- 8) Install the attachment strap (3) together with the doubler (5) with the rivets (6) to the seat pan (4).
- 9) Add the "MOD1" to the P/N on the seat name plate (7). The name plate is located at the bottom surface of the pan (4).
- 10) Attach the cushion (1) to the seat pan (4).
- Obey the instructions provided in the PC12 aircraft maintenance manual (AMM) to install the seat into the cockpit.
