SERVICE LETTER

**SUBJECT: PRATT & WHITNEY CANADA (P&WC) SERVICE INFORMATION LETTER (SIL)
NO. PT6A-116 R2**

REVISION 2 TO P&WC SIL NO. PT6A-116 - BORESCOPE INSPECTION IN CONJUNCTION WITH FUEL NOZZLE CHECK

Subject: Borescope Inspection in Conjunction with Fuel Nozzle Check

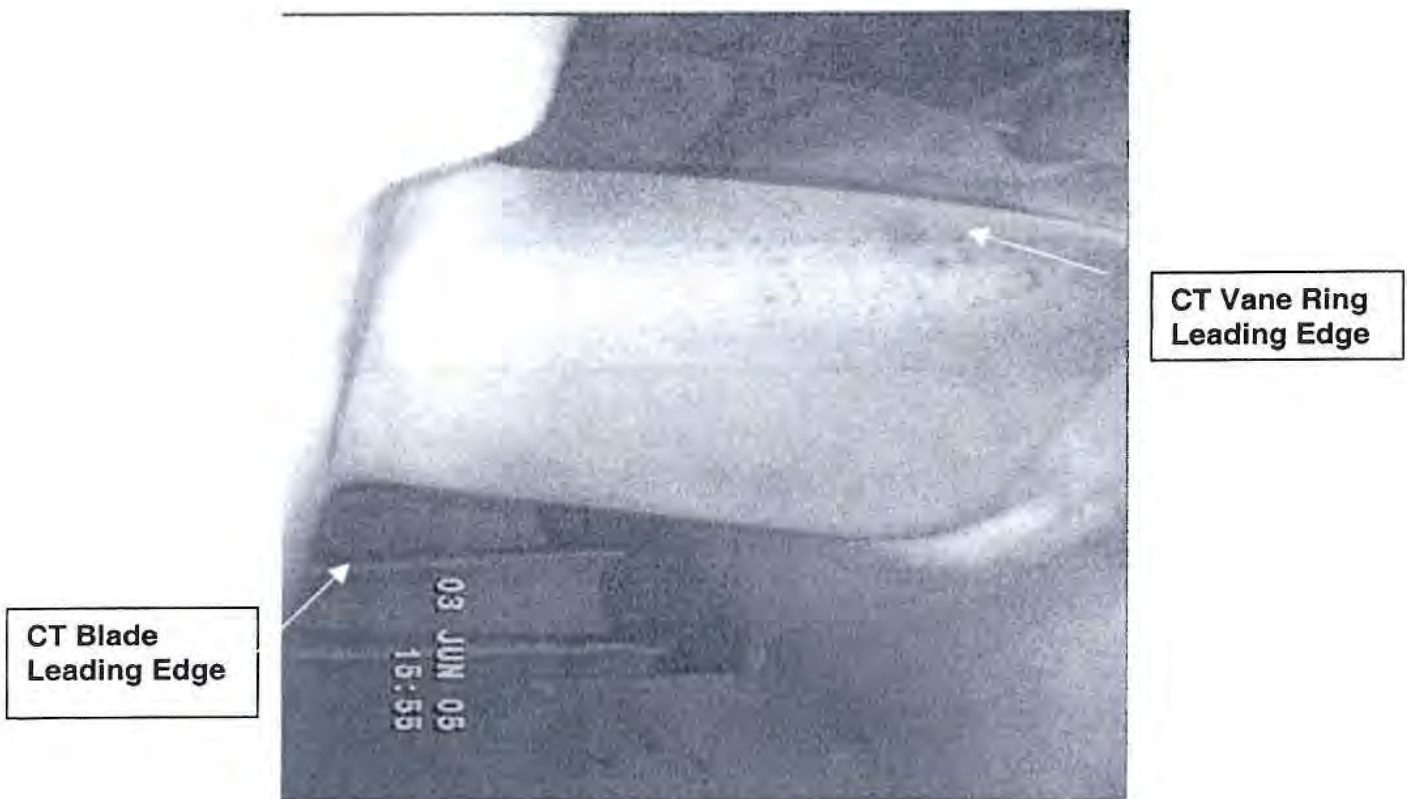
Fig. 1- View of CT Vane Ring and Blades

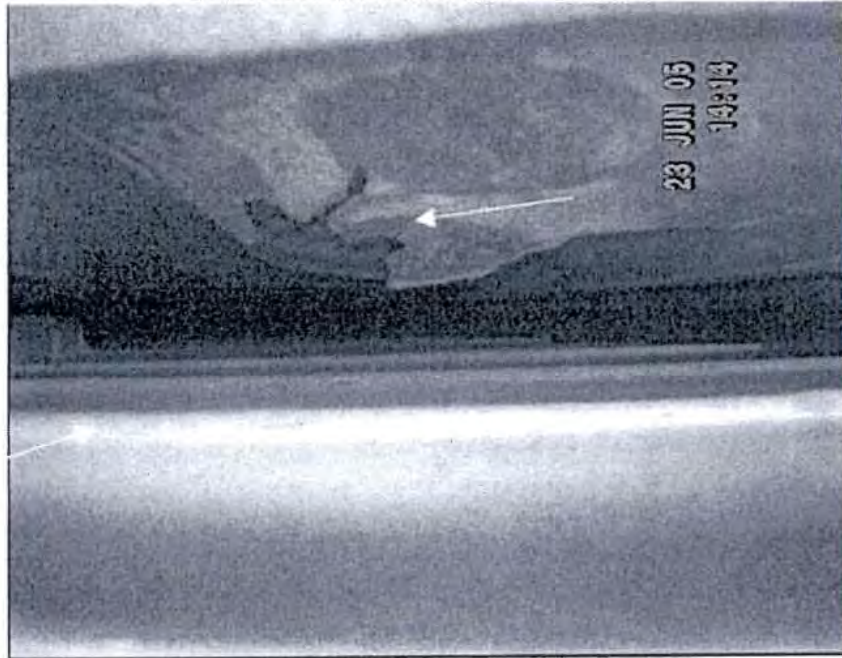
**CT Vane Ring
Burnt Trailing
Edge**

**CT Blade
Leading**

Fig. 2- View of CT Vane Ring Trailing Edge

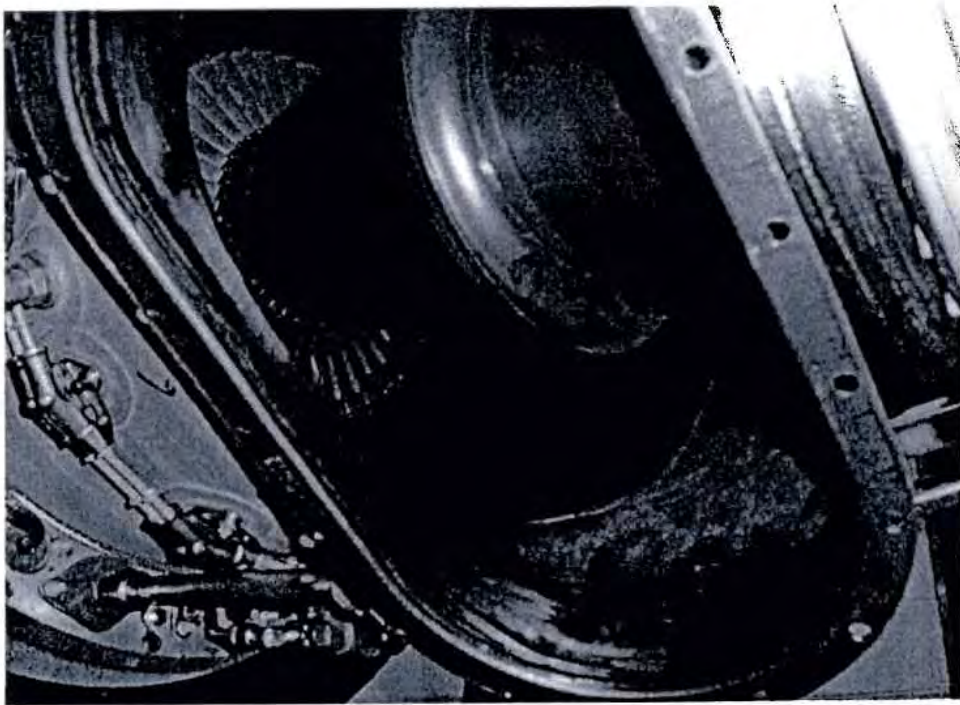
Fig. 3 – Exhaust Duct Port

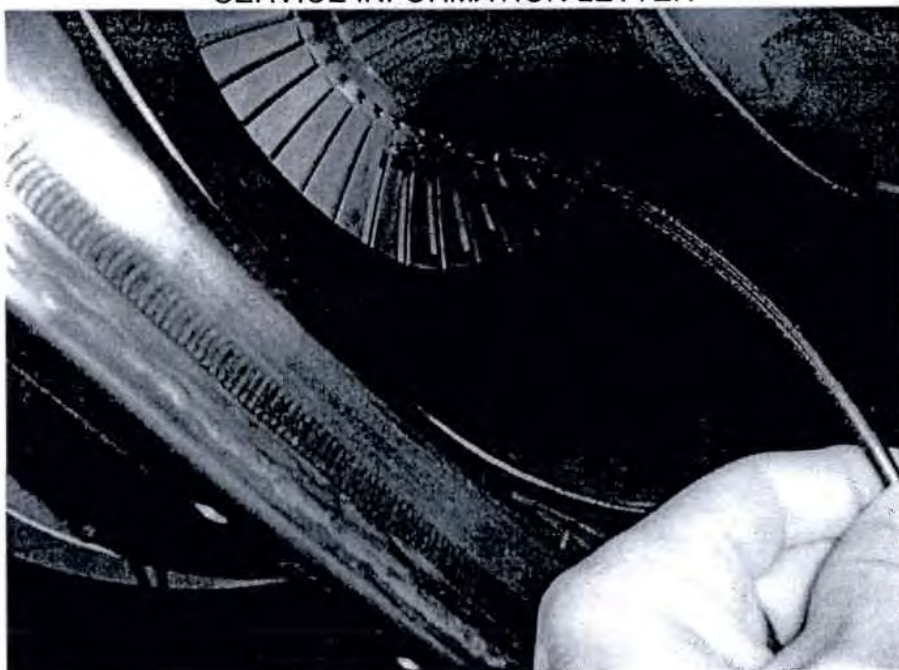
Fig. 4 - Fiberscope inserted in exhaust duct port

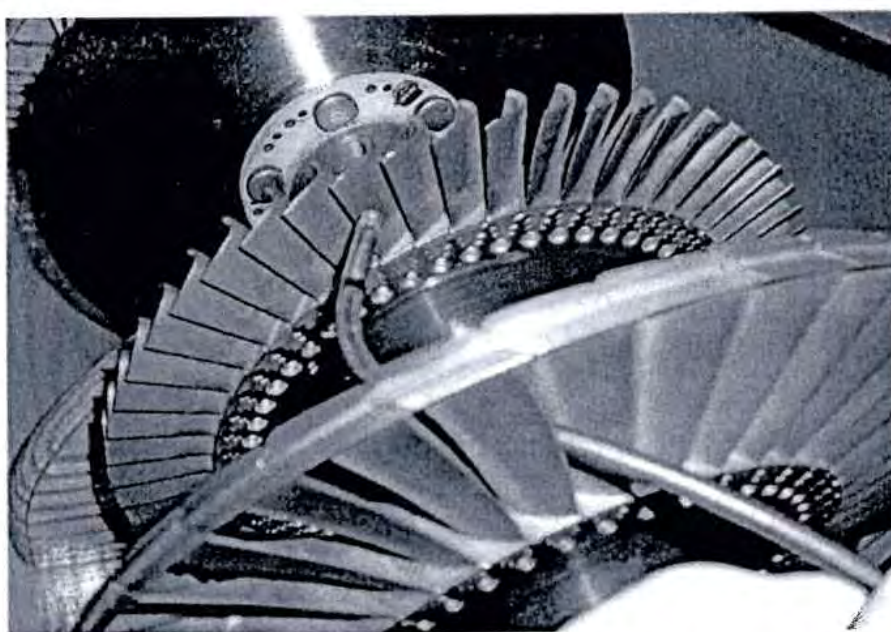
**Fig.5 – View of Fiberscope inserted between PT blades and distal tips clear of CT blades
(For reference only Power Turbine Vane Ring missing)**

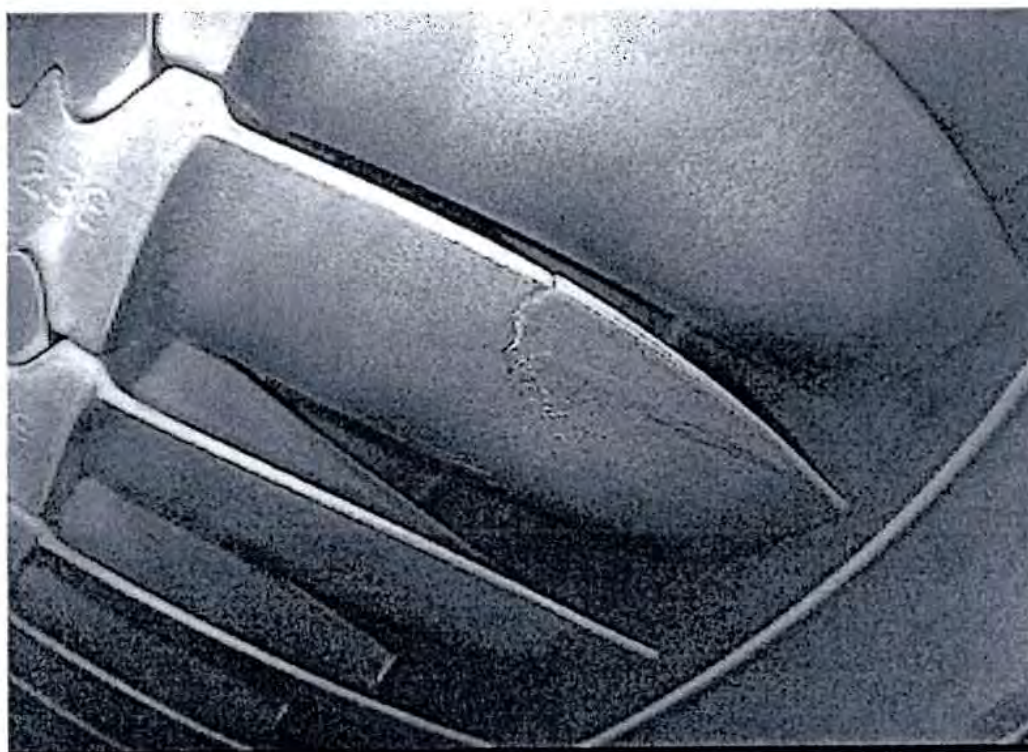
Over the past 12 months Five (5) operators reported to P&WC that they were able to detect Trailing edge cracks on the Compressor Turbine Blades using this new procedure, by inserting the fiberscope through the exhaust duct port and the power turbine stage. The new procedure was introduced in the EMM in May 2006.

Fig. 6 –Borescope View of the CT blades obtained through the exhaust duct port and the power turbine stage showing a trailing edge crack

In light of the possible consequences listed above, P&WC wishes to remind operators of the importance of performing borescope inspection during fuel nozzle check as per the EMM. For operators who have not been complying to this requirement P&WC recommends that a borescope inspection be scheduled at their earliest convenience and that this practice be incorporated as part of their normal scheduled fuel nozzle maintenance.
