SUBJECT: FUEL CONTROL UNIT - INSPECTION OF CASTING WALL THICKNESS

PRATT & WHITNEY CANADA
SERVICE BULLETIN

TURBOPROP ENGINE
FUEL CONTROL UNIT - INSPECTION

ENGINE FUEL AND CONTROL - FUEL CONTROL UNIT (FCU) - DOCUMENTATION OF FIELD INSPECTION FOR POSSIBLE CASTING THIN WALL CONDITION

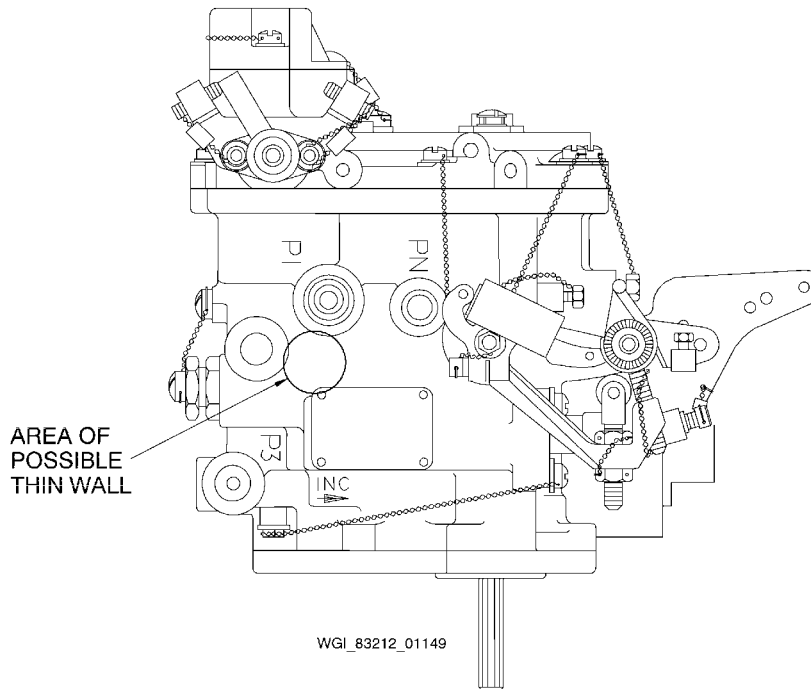
Figure 1 - Thin Wall Inspection Area
(Sheet 1 of 1)

Problem: A possible thin wall condition exists on 98 field units for the drilled passage between the inlet port and the minimum flow orifice. If not inspected within the first 500 service hours the thin wall condition could cause a high pressure external fuel leak at the aircraft engine.

Cause: Casting tooling was produced to a solid model that did not comply with the casting drawing requirements, resulting in insufficient stock in a specific location.

Solution: Casting tooling was modified to reflect the casting drawing requirements. Inspect field units for wall thickness within the first 500 service hours. Replace unit within the first 500 service hours if reading is less than 0.031 inch (0,79 mm).

- (1) Use Woodward Governor Company Quality System Standard Operating Procedure 3-09-3592 Ultrasonic Thickness Measurement procedure to inspect wall thickness of housing in area specified in Figure 1 with ultrasonic inspection equipment listed in Tooling - Price and Availability section above.
- (2) A reading of less than 0.031 inch (0,79 mm): Replace within the first 500 service hours.
- (3) A reading equal to or greater than 0.031 inch (0,79 mm): Unit may remain in operation indefinitely.
