SUBJECT: ALL PC-12 SERIES AIRCRAFT - EMERGENCY POWER SUPPLY - L-3 COMMUNICATIONS AVIONICS SYSTEMS SERVICE BULLETIN SB501-1712-11

SB501-1712-11 (Rev. A)

PS-855 – Prevent Short Circuits

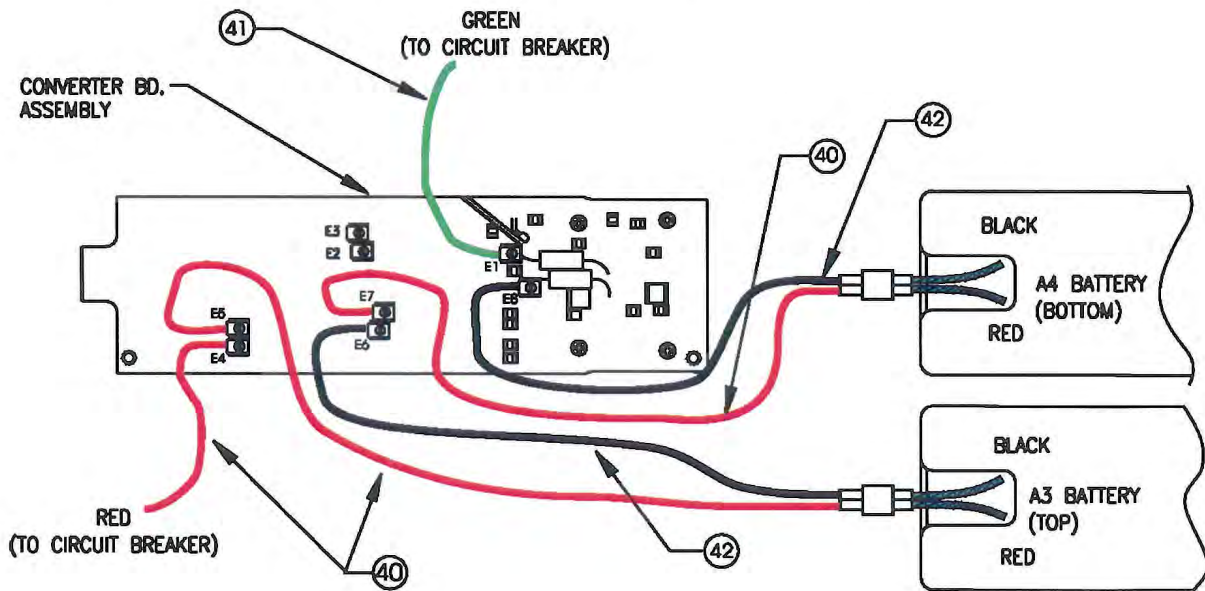
Figure 1

L-3 Communications Avionics Systems have issued Service Bulletin SB501-1712-11 to advise of the possibility that insulation failure within the PS-855 Emergency Power Supply (EPS) may cause an internal short circuit.

Reason: To eliminate the potential for short circuits due to insulation failure.

6. Remove bottom Battery Back (A4) from Chassis Assembly and set to the side.
7. Refer to Figure 1(below) and add new sleeving as follows:
 - a. From converter assembly CCA (A1) disconnect green wire from terminal E1 using small regular screwdriver. (Wire connects to Circuit Breaker, CB1.)

- Trim a piece of green Silicone Coated Fiberglass Sleeving (P/N MIL-I-3190/6-10-5) that is long enough to cover the green wire from the Terminal E1 up to the rubber Grommet (through the CCA A2).

- Slide sleeving over green wire and reconnect wire to terminal E1.

- b. From converter assembly CCA (A1) disconnect red wire from terminal E4 using small regular screwdriver. (Wire connects to Circuit Breaker, CB1.)
 - Trim a piece of red Silicone Coated Fiberglass Sleeving (P/N MIL-I-3190/6-10-2) that is long enough to cover the red wire from the terminal E4 up to the rubber grommet (through the CCA A2).

- Slide sleeving over red wire and reconnect wire to terminal E4.
- c. From converter assembly CCA (A1) disconnect red wire from terminal E5 using small regular screwdriver. (Wire connects to top battery, A3.)
