SUBJECT: DEFECTIVE SELF-LOCKING NUTS - MS21042

Date: Jan 24/13

SIB No.: 2012-06R1
Issued: 07 August 2012

Subject: **Defective Standard Hardware – MS21042, NAS1291 and LN9338 Self-Locking Nuts, and NAS626 Bolts**

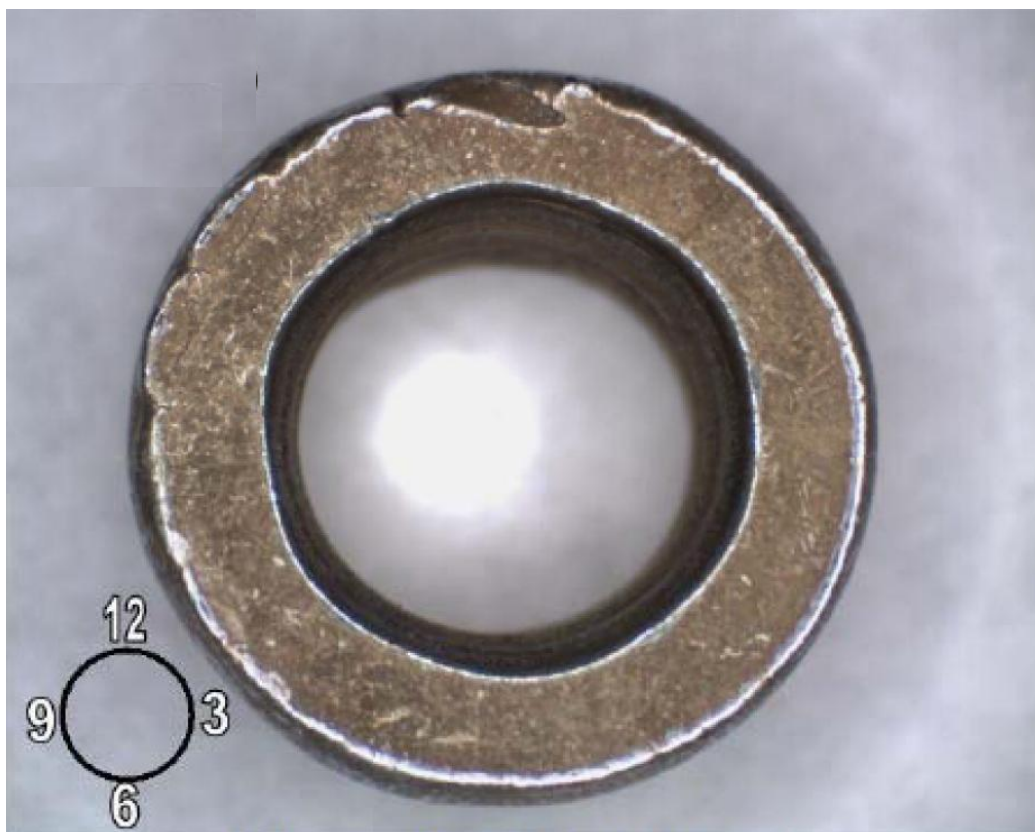
Self-locking nuts have been found cracked, parallel to the nut axis, and in some instances, only a short time after installation.

Figure 1: Example of surface irregularities observed on a nut. Overall view.

Recommendation: Manufacturers, aircraft owners, operators and maintenance staff, are recommended to subject the standard hardware (as identified in the Applicability paragraph of this SIB) to a close visual inspection for surface irregularities, such as gouges or cracks, as illustrated in Figures 1 and 2 of this SIB, before being installed on a product.

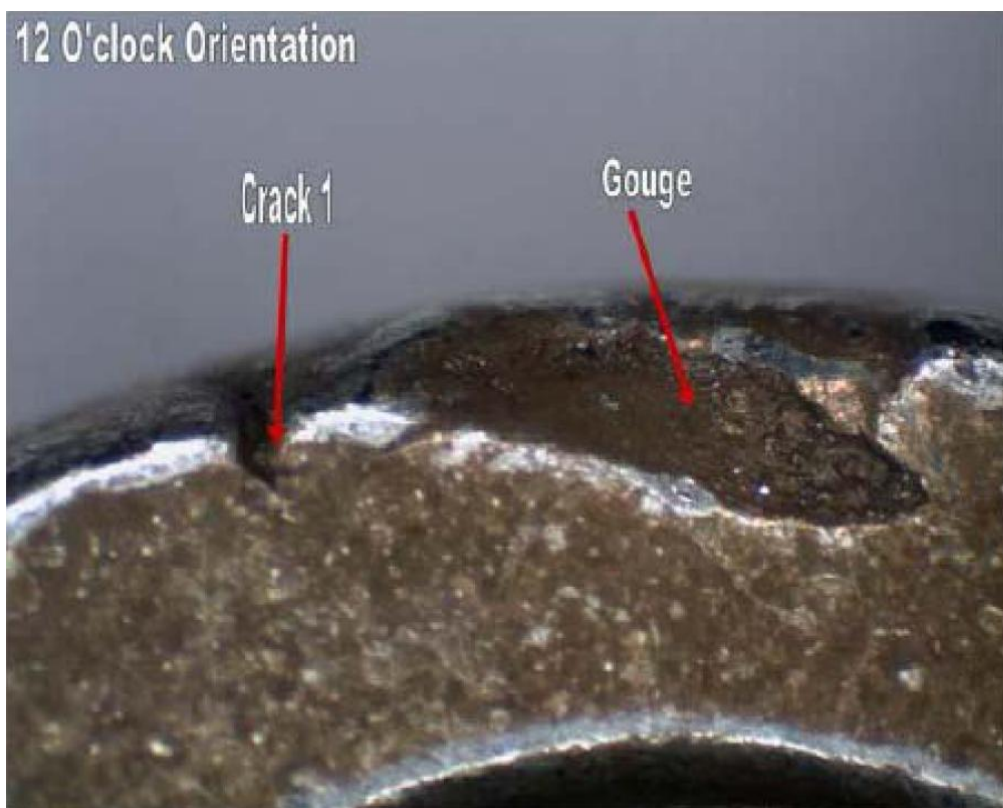
Figure 2: Example of surface irregularities observed on a nut. Detail

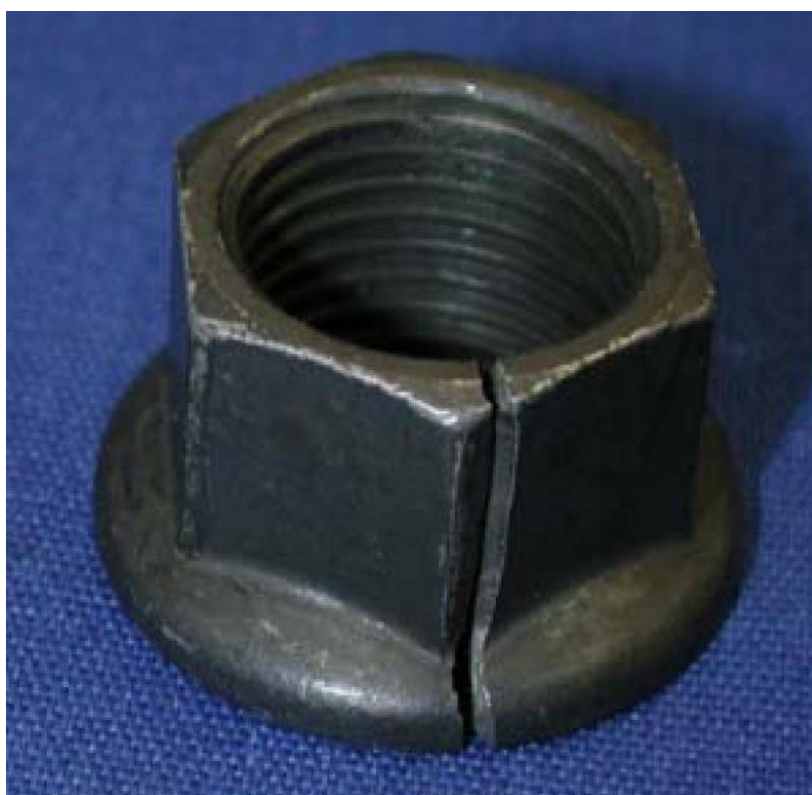
Figure 3: Example of longitudinal crack.

In addition, it is recommended to subject incoming lots of self-locking nuts (as identified in the Applicability paragraph of this SIB) to a torque check and inspection, before receiving them in stock, as follows: Install the nuts on the appropriate bolts, with spacers as required, and keep them torqued (see relevant torque values in Table 1 of this SIB) for 1 week. For statistical reasons, a quantity of 1% (round up) or 20 nuts of one manufactured batch – whichever is less – should be tested. After the test period, visually inspect the nuts for cracks on the bearing surface or longitudinally as illustrated in Figure 3 of this SIB.

Suspect parts should be quarantined until conformity to the manufacturing standard is verified.
