**This Transmittal Sheet applies to the Revision 02, dated 20140625, of Service Bulletin MC10-35-274**

## SERVICE BULLETIN

### TITLE: OXYGEN – HARNESS ASSEMBLY - INSPECTION FOR POTENTIAL DEFECTIVE COMPONENT

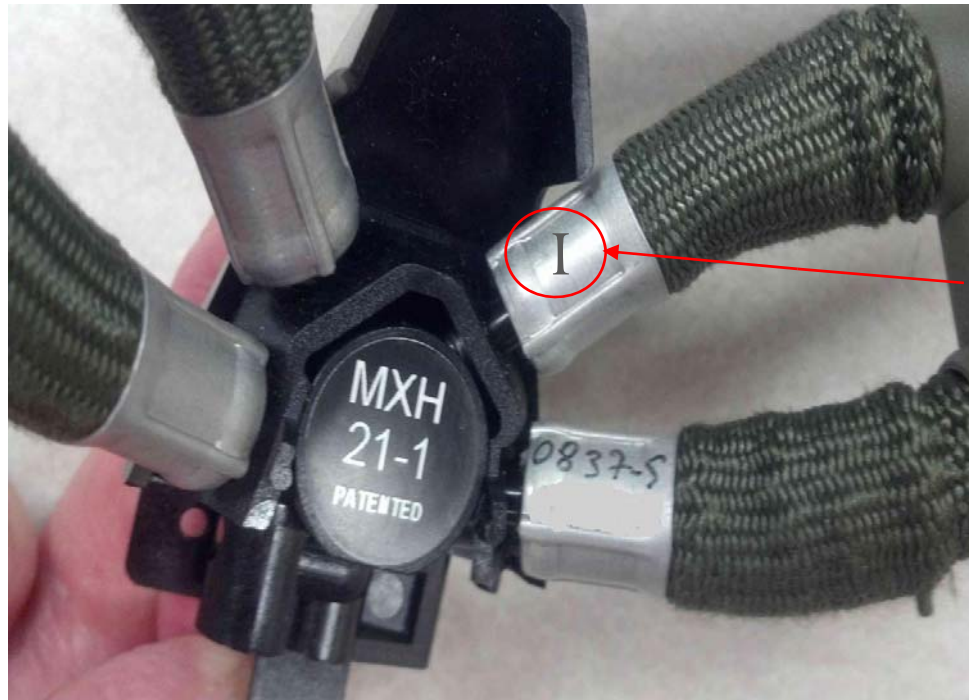
Figure 1 – “I” Letter Position

With indelible ink or an electric pen, write visibly the SB accomplishment by adding of letter "I" (Inspected) on the bushing of inflatable harness (See Figure 2).

The marking shall be visible once the harness has been re-installed on the mask.

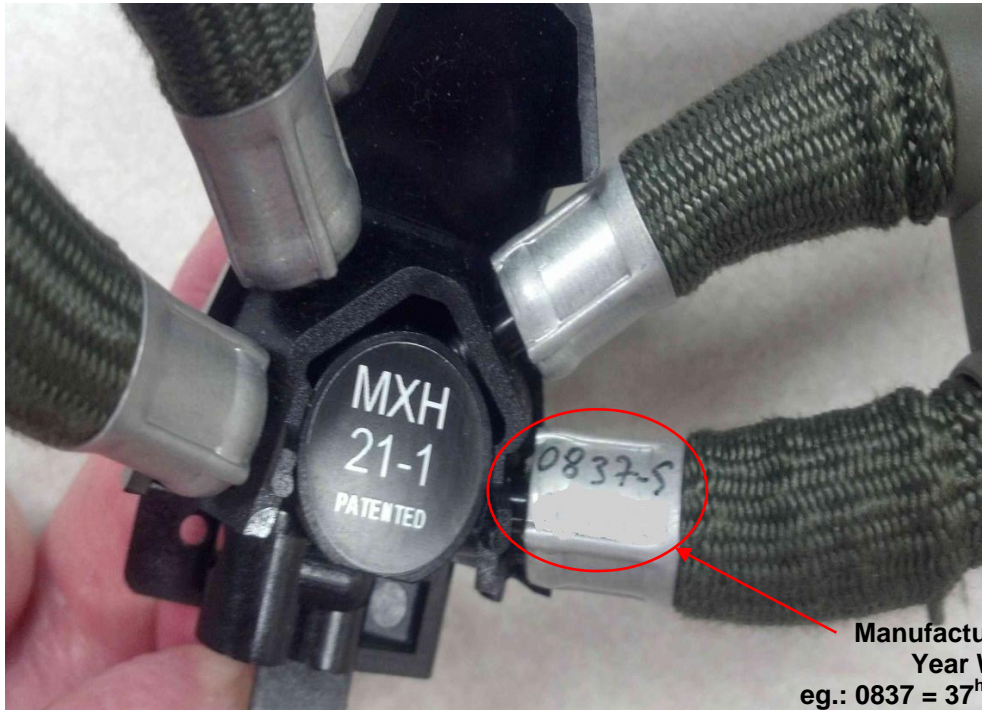
Figure 2 – Manufacturing Date Explanation

This Service Bulletin applies to the harness hose equipped PNR 445186 or 445952 fitted on the inflatable harness assembly PNR MXH20-1 or MXH21-1 and manufactured between 50<sup>th</sup> week of 2008 year (0850S) and 51<sup>th</sup> week of 2010 year (1051S).

(1) Inspect the manufacturing date (See Figure 3) of the inflatable harness or harness hose equipped :

**Manufacturing Date  
Year Week**  
eg.: 0837 = 37<sup>h</sup> week of 2008

- If the manufacturing date is in the specified period above, forward the defective inflatable harness or harness hose equipped to the appropriate Zodiac Services maintenance facility for replacement of the inflatable harness.
