**PPG Aerospace**  
Transparencies

**Subject:** Manufacturing effects on Pilatus PC-12 Main Windshields

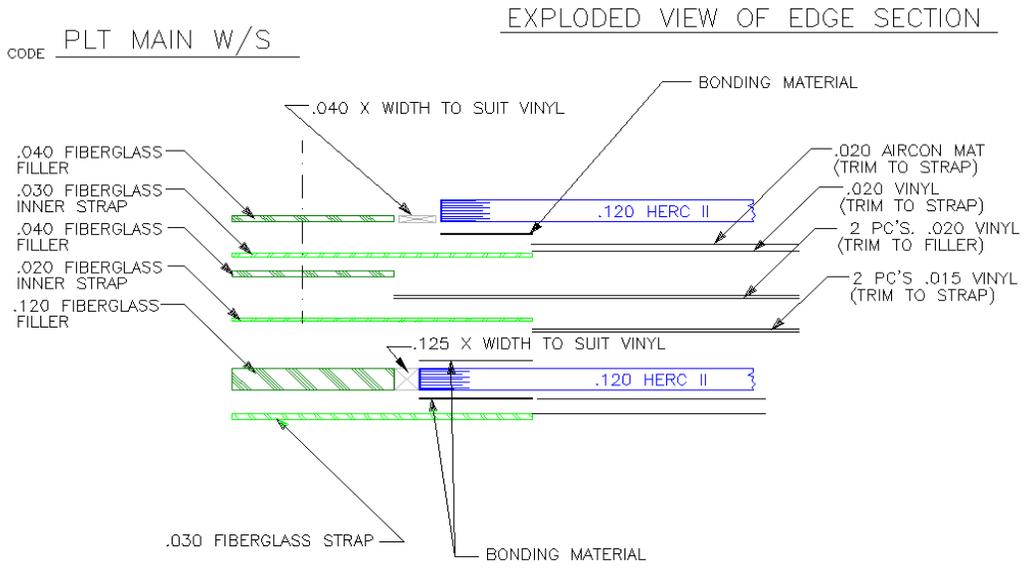
**Photo #4 Cross Section of PC-12 Main Windshield**

This observation is NOT "delamination, a scratch or a crack". To achieve the weight to strength ratio required for this window the design incorporates a fiberglass edge strap that frames the actual glass and is the mounting surface for the windshield. The mounting bolts extend through the fiberglass edge strap increasing the strength of the windshield for pressurization and bird strike integrity. The Pilatus windshield incorporates an anti-icing system called an Aircon mat that has 4 separate heating zones. The 4 heating zones require 4 separate "braid" wires to supply the current and 3 separate "sensing elements" that operate as a "thermostat" to power the window "on & off". Only 1 sensing element is utilized at a time with the other 2 being redundant "spares", increasing the service life of the window for the Customer. This reduces expensive window replacement in the event the "sensing element" fails when one of the 2 backups can be wired up and flight operations continued. A "cross section" of the window is provided below to illustrate the basic window design (Photo #4).

NOTE :  
FIBERGLASS STRAP PENETRATION ON GLASS = .60 ALL SURFACES EXCEPT TAB PROJECTIONS.
